# Pile Driving Record

## Harbor Point Marina, Dock C

PILE ID

Bent 30 / Pile D

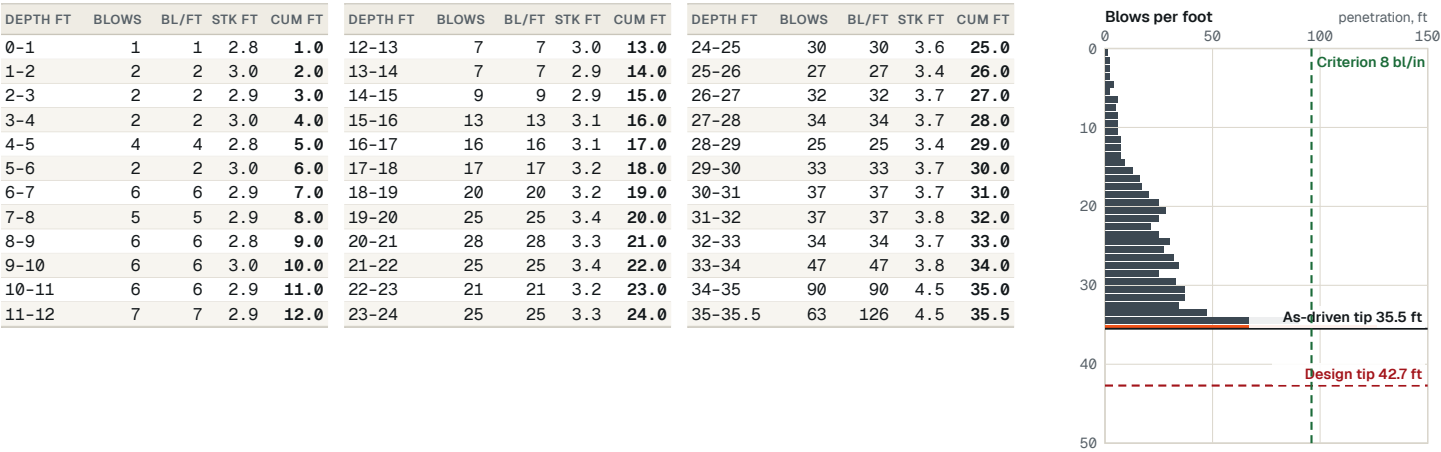
DRIVING LOG

36 increments · 751 blows · 35.5 ft

FINAL SET (LAST 6 IN)

10.50 blows/in

63 blows in 6 in

CRITERION MET

Likely cause: A dense lens above the design tip met the blow-count criterion early, so the hammer stopped short of the design tip. The pattern matches the other piles in bents 30 to 36 (false set).

Suggested remediation: Re-strike after set-up: Confirm the disposition with the engineer of record before work proceeds.
